GLOBALSTONE
c o n g r e s s 2 0 2 3

INVESTIGATION OF THE EFFECTS OF FIRE ON STONE MATERIALS: THE RIO DE JANEIRO CASE

This paper discusses the need for in-depth studies to understand the damage caused by fires on heritage stones in Brazil, particularly on stony monuments. The article highlights two common types of heritage stones found in Rio de Janeiro, Facoidal gneiss and Leptinito gneiss, and describes the changes in some properties when exposed to high temperatures.

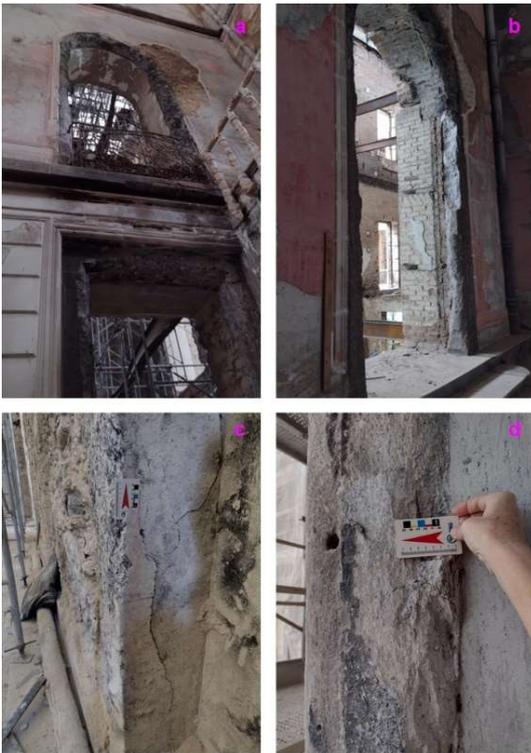
Figure 1 shows the aspect of some of those elements after the fire.

Figure 1: National Museum rocks after fire.

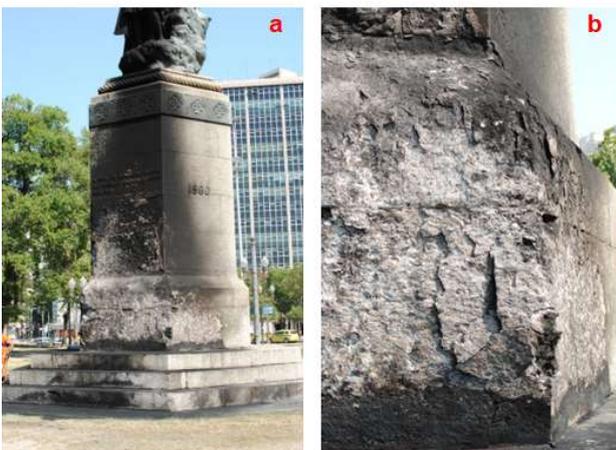
The Monument to Pedro Álvares Cabral (Figure 2) was fired during a protest against the modification of the indigenous law. Flammable material (rubber tyres and oil) was ignited on the Monument's pedestal base. The Monument was commissioned as part of the fourth centenary of the Discovery of Brazil commemorations, celebrated in 1900. The work by Rodolfo Bernardelli has a 10-meter pedestal in Facoidal gneiss over which bronze sculptures of three important historical figures stand: Pedro Álvares Cabral, commander of the fleet that arrived in Brazil in 1500; Pero Vaz de Caminha, clerk of the fleet; and Friar Henrique de Coimbra, chaplain and celebrant of the first mass (Tabet & Puma, 1983).

Figure 2: a) Monument aspect the day after fire and b) Detail of the damage. Photos by Pedro Dias.

The visible effects of fire in the FAC of the monument are related to cracking (fractures), exfoliation, loss of material (rounding off the edges), black deposits (fumes and ashes), and staining (oil), as seen in Figure 2.

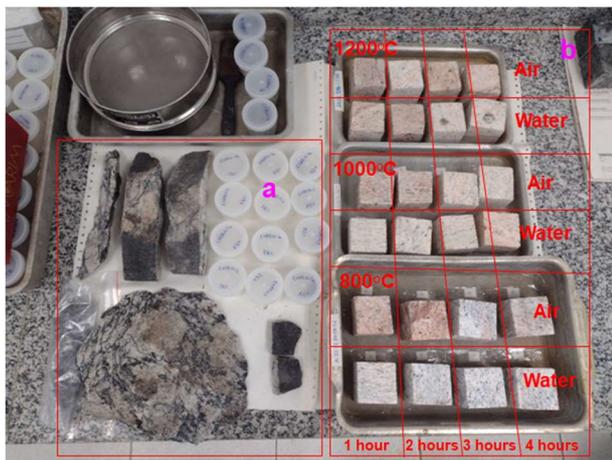
specific rock, but in the case of the monument to Pedro Álvares Cabral, the City Hall of Rio de Janeiro provided two scales of FAC that came loose due to the fire: one external, directly exposed to the fire, and one from the immediate inner layer (Fig. 4).

The external piece was cut in three parts for observation in a stereoscopic magnifying glass (*Carl Zeiss*), and then the soot, fumes and ash were scraped off for future analysis. X-ray diffraction analysis (XRD), scanning electron microscopy (SEM, *Hitachi TM3030Plus*) with an EDS detector (*Bruker Quantax 70*), bulk density, apparent porosity, and water absorption (ABNT NBR 15845-2), Leeb surface hardness - HLD (*Equotip 3, Proceq*), p-waves ultrasonic velocity - UPV (*PUNDIT PL-200, Proceq*), and colour (*CieLab, Spectroguide Sphere Gloss, BYK Gardner*) were determined and compared to those obtained in fresh samples from reference data from CETEM (Fig. 4a).

Twenty-four cubic samples of LEP were extracted from a block donated for academic studies by the São Bento Monastery (Fig. 4b). They were heated in a muffle furnace at three different temperatures (800, 1,000, 1,200°C), four residence times (1, 2, 3, and 4 hours), and two different cooling methods, air and cold water.

Figure 4: Samples in this study. a) Monument pieces of FAC and b) Cubic samples of LEP.

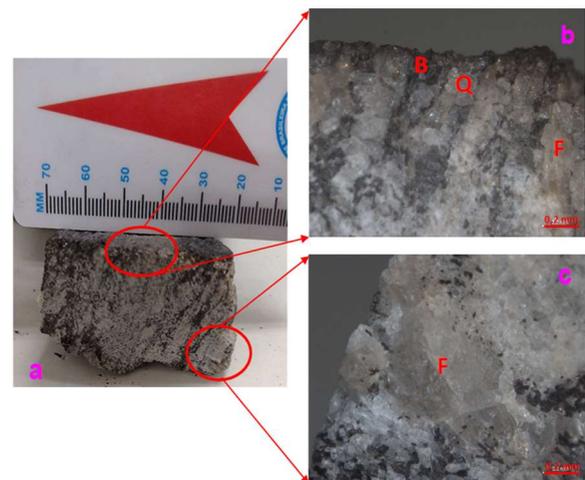
The FAC sample exposed to the fire (Fig. 5) presents colour changes and cracking. Regarding colour, it exhibits the three distinct zones described by Gomez-Heras (2006), from the surface to the inner part: superficial deposits of fumes and ashes (Fig. 5a), a thermal oxidation reddish zone (Fig. 5b) and the standard rock colour. Large feldspar crystals show cracks (Fig. 5c). The inner part shows some staining on the front but no apparent alterations on the back.

Figure 5. Normal cut of the FAC fired surface: fumes and ash external deposits (a); thermal oxidation zone (b); and feldspar cracking (c). B: biotite, Q: quartz and F: feldspar.

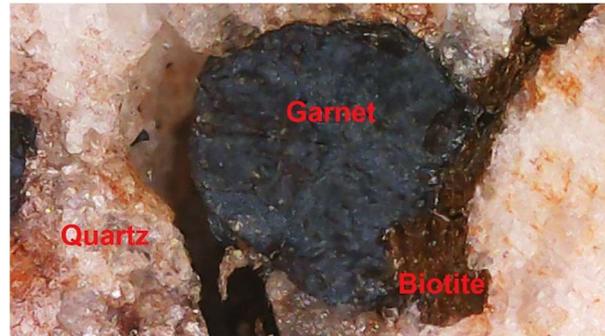
LEP regular and parallel foliation offers weakness planes where some fractures developed with temperature. It has higher quartz content than FAC. Quartz content is a critical parameter for the fire decay on silicate stones, having volumetric expansion much higher than other rock-forming minerals and anisotropic behaviour regarding linear thermal expansion (Winkler, 1997). Quartz thermal expansion grows with increasing temperatures and is twice as high perpendicular to the c axis, producing ever-growing thermal strains inside the stone, up to 573 °C, when thermal strains stabilize (Sciarretta et al., 2021). At temperatures beyond 573 °C, such as the ones in this experiment, the transition from low-to-high quartz changing the crystalline arrangement entails a huge expansion producing eye-naked visible cracks, as observed by Nemeth et al. (2021). Silicate rocks' residual strains (after cooling) are high if heated at more than 700 °C when the stones expand through the crack's growth and intergranular cracks formation (Sippel et al., 2007). LEP mineral composition and arrangement may have affected the observed thermal decay. It has high quartz content and, probably, higher thermal expansion perpendicular to foliation than parallel, as the mylonitic orthogneiss studied by Sippel et al. (2007). Cracks were observed in grain boundaries, as shown in Figure 10.

Figure 10: Detail of garnet-quartz contact with a fracture and garnet-biotite-quartz without fracture. Sample of LEP subjected to 1200°C for two hours and cooled naturally.
