GLOBALSTONE
c o n g r e s s 2 0 2 3

PROCEEDINGS

MINERAL ALTERATIONS CAUSED BY LIGHTNING IN THE CHRIST OF THE REDEEMER SURFACE, RIO DE JANEIRO, BRAZIL

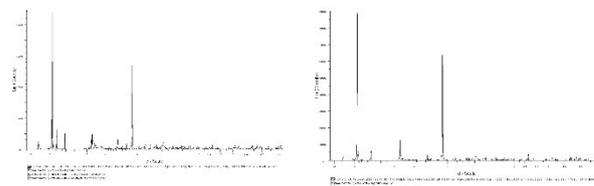
Figure 4: Tesseræ 1930 XRD. Figure 5: Tesseræ 2000 XRD.

As illustrated in Figures 4-6, the X-ray diffraction analyses carried on the tesserae (1930, 2000 and 2010) present peaks of talc and tremolite. Figure 7 shows the X-ray diffraction of the arms (lightning) samples, where is possible to see peaks of calcite and dolomite. This is credited to the dissociation of magnesium or calcium silicate and transformation in magnesium or calcium carbonate, at the high temperature and pressure of storm. Samples from the regions of the monument that suffer from lightning rays (head and arms) present mineral alterations, with dolomite or calcite formation. It is possible that the high pressure and temperature of the rays, promote the chemical bonding of the magnesium present in the soapstone structure with the atmospheric CO_2 , indicating the formation of calcium carbonate or magnesium.

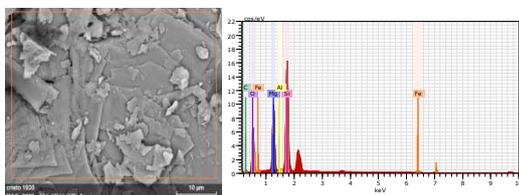
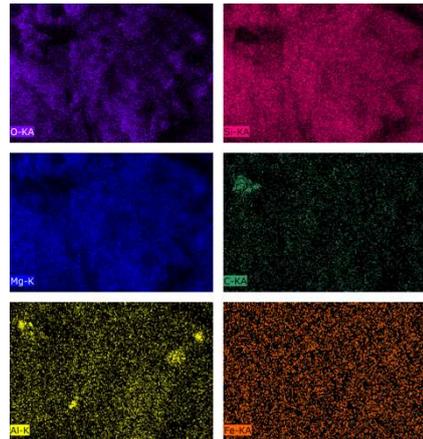
Figure 10: SEM/EDS mapping Tesseræ 1930.

Figures 10, 11 and 12 shows the SEM results for 1930, 2000 and 2010, respectively. They show the presence of Si, Al, Mg and Fe in the mapping and EDS corroborating the results of FRX and XRD.

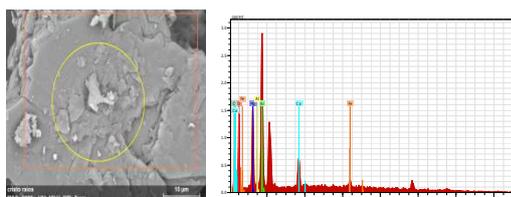
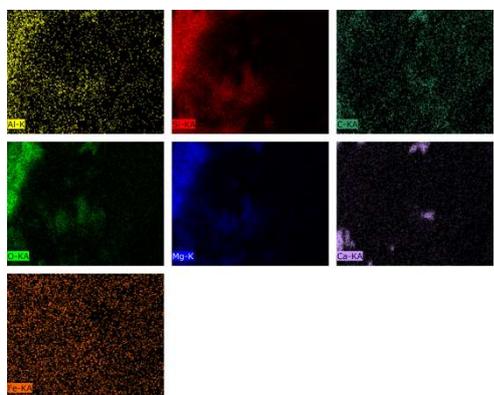
Figure 13: SEM /EDS mapping Tesseræ lightning.

Figure 13 shows the SEM/EDS result of the sample of lightning where calcium carbonate or magnesium formation can be inferred from the presence of carbon, magnesium, calcium and oxygen. This results agrees with the theory of those minerals formation in the monument.

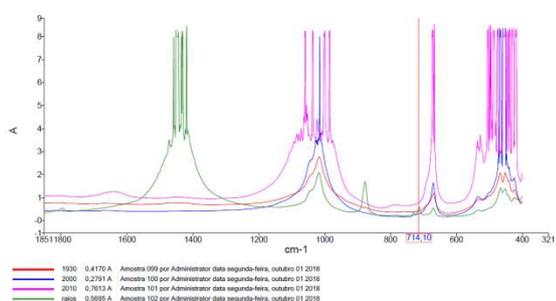
Figure 14: FTIR results of samples.

Figure 14 shows the FTIR results where it is possible to verify, between 1,400 and 1,500, characteristic peaks of the formation of carbonates (Mg and Ca) in the sample that was attacked by the lightning-rod (green line), confirming the formation of these minerals due to the alteration of the soapstone at high pressures and temperatures.

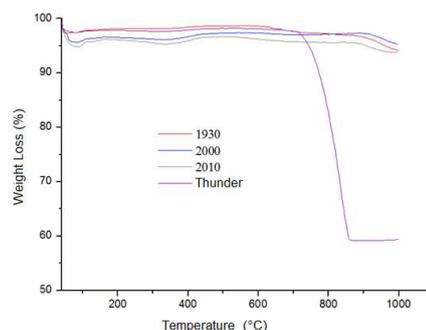
Figure 15: TGA results of samples.

Figure 15 shows the results of the TGA evaluation of the samples, where it can be observed that the tesseræ of 1930, 2000 and 2010 are very stable, with a mass loss around 5% at 1,000 °C. On the other hand, the sample attacked by the lightning, presents a differentiated behavior, with mass loss of more than 60% at 900°C, supporting the previous results, once again, of the possible carbonates formation, and alteration of the soapstone.
